UNIVERSITY OF PENNSYLVANIA GEORGE A. WEISS PAVILION AT FRANKLIN FIELD

PRESENTED BY: JENNIFER PEIRCE BRANDT, P.E. PEIRCE ENGINEERING, INC.

PROPOSED WEISS PAVILION

PE INC. PROJECT TASKS

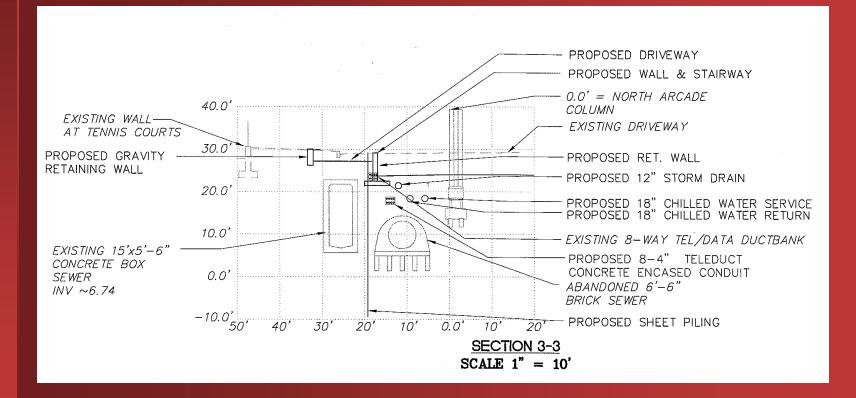
Typical cross section (looking East)

- Obtained 1985 as-built plans for existing soldier beams at box sewer from previous contractor
- Located existing soldier beams by test pit
- Checked existing beams for 9 ft cantilever with 3 ft sloped surcharge and 2 ft construction surcharge
- Recommended soil values

g = 125 pcf, F = 30 deg, Rankine Ka and Kp
- PE, Inc. design soil values

g = 115 pcf, F = 30 deg, Coulomb Ka and Kp
- Saved 68 ea. HP12x53 soldier beams \$\$\$

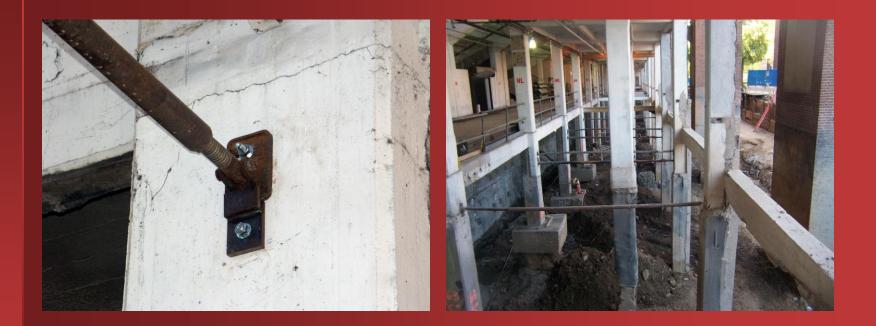
TEMPORARY LATERAL WALL BRACING

Installed braces at existing concourse elevation between columns where structural slab demolition occurred

- Design Load = 6.5 kips per column
- Dayton/Richmond B-4 pipe brace bolted to existing concrete columns

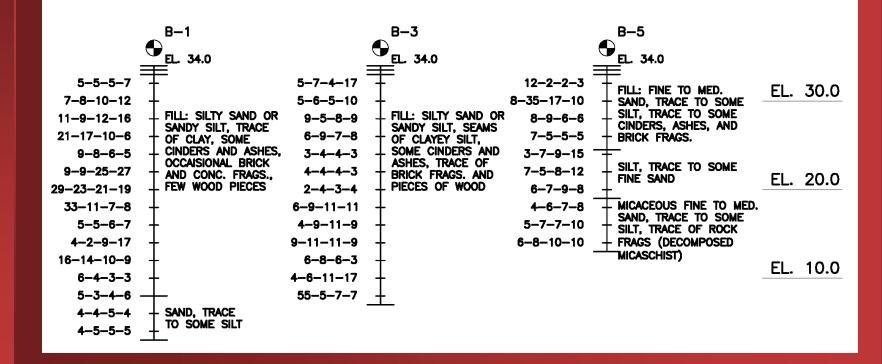
Additional soil borings from Geotech, Inc. for JPC taken along soil nail wall location

- Geotechnical recommendations

In-situ soil values g = 125 pcf, F = 30 deg, Rankine Ka and Kp
 - Pressure Grouting (Type?) for improved soil values g = 125 pcf, F = 40 deg, soil/grout bond = 15 psi allowable
- PE, Inc. design values (JPC borings)
 - Soil values g = 125 pcf, F = 30 deg, c = 0 psf, soil/grout bond = 10 psi allowable/20 psi ultimate

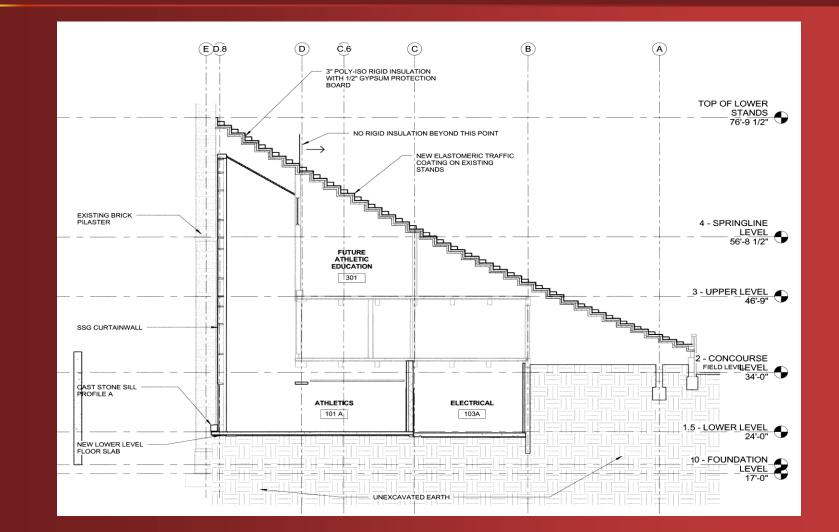
Design

- Goldnail
- Discovered space between structural slab and top of existing fill, therefore, reduced total wall height (2 ft wall height reduction \$\$\$)
- Preliminary cut verified stability of proposed vertical excavation lifts
- Wall length approximately 480 ft long
- Wall height H = 16.5 ft, H' = 18.5 ft
- 3 tier wall, 5 inch diameter drill holes
- Nail spacing 4.8 ft H x 5 ft V, top nail @ 3 ft
- #8, Grade 75, epoxy coated threadbars
- 4 in temporary shotcrete with 6 in permanent shotcrete

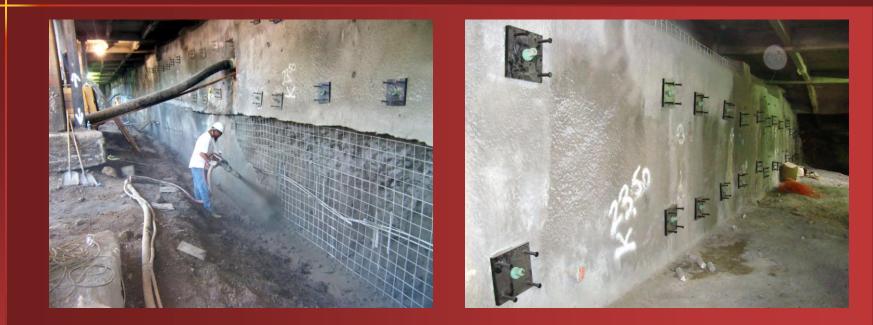
- 2nd lift of temporary shotcrete face
- Finished temporary face with 12"x12"x1" studded plates

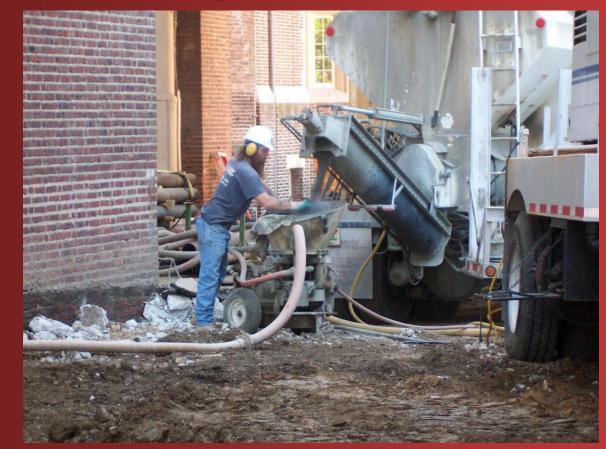
Dry mix shotcrete (gunite) hopper

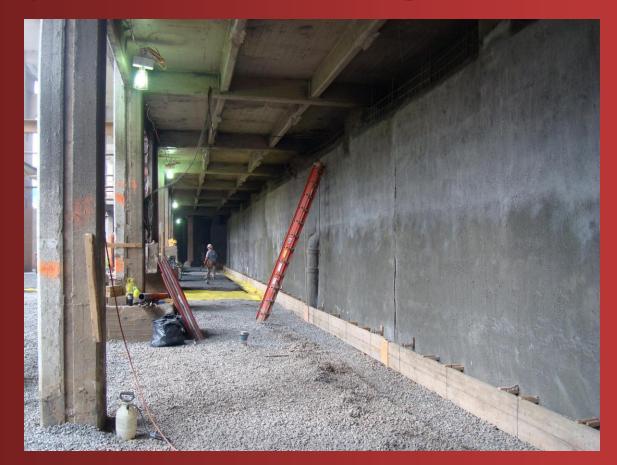
6 inch permanent shotcrete facing
